**Flood Control Project Maintenance
Levee Inspections****LMA District Cover Sheet****Spring 2014 Levee Inspection Results****American River Flood Control District**

Spring 2014 Levee Inspection Results

American River Flood Control District

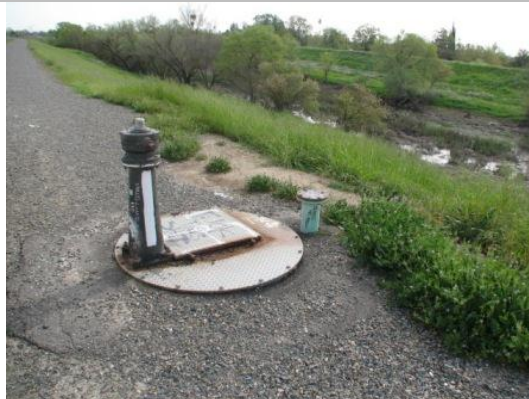
Photo 1 of 1 : mkhashch_s_20140428_00309.jpg

LM Start	0.36	Rating **	A/W	Issue No.	17
LM End	0.36	Issue Type +	En	Location *	CR
Category	Earthen Levee			GPS Latitude/Longitude	
				Start	End
Item	Encroachments			38.623325 °	38.623325 °
				-121.462217 °	-121.462217 °
DWR ID	DWR_NA0001_07_s _ 2012_17				
Action/Comments					
Pipe Inspector Comments: Closure device for sewer line located on levee crown.

Closure device for SS beneath channel.

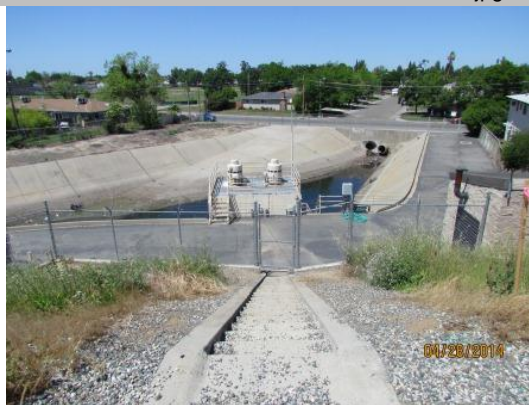
Photo 1 of 1 : mkhashch_s_20140505_00945.jpg

LM Start	0.58	Rating **	A/W	Issue No.	42
LM End	0.58	Issue Type +	En	Location *	CR
Category	Earthen Levee			GPS Latitude/Longitude	
				Start	End
Item	Encroachments			38.625311 °	38.625311 °
				-121.458994 °	-121.458994 °
DWR ID	DWR_NA0001_07_s _ 2014_42				
Action/Comments					
Pipe					
Inspector Comments: Two pipes crossing the levee.

View of the pump station on the landside levee toe.

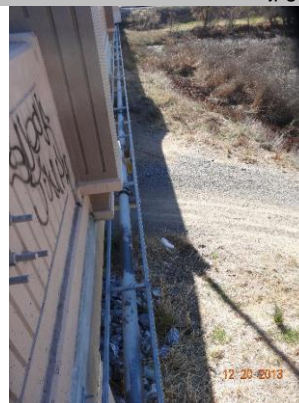
Photo 1 of 1 : UCIP_6201.jpg

LM Start	0.70	Rating **	M	Issue No.	36
LM End	0.70	Issue Type +	En	Location *	CR
Category	Supplemental			GPS Latitude/Longitude	
				Start	End
Item	DWR UCIP Field Study			38.624843 °	38.624843 °
				-121.457097 °	-121.457097 °
DWR ID	DWR_NA0001_07_s_2014_36				
Action/Comments					
Inspector Comments: FS_ID:29237					
EP_NO: 3417					
Repair Type:					
Crossing Status:					
UCIP Comments: Missing gas line markers -- need to contact owner to determine status.					
FIELD_STRUCT_DESC: 4-inch steel gas line through the levee, 2.0 feet below the crown. CM cutoff wall around pipe at center of levee.					
(Permit No. 3417-1961) Landscaping and staircase on landward slope added under Permit No. 3510 (1978), but was removed in 1994.					
FS Date: 12/20/2013

View of pipe attached to bridge.

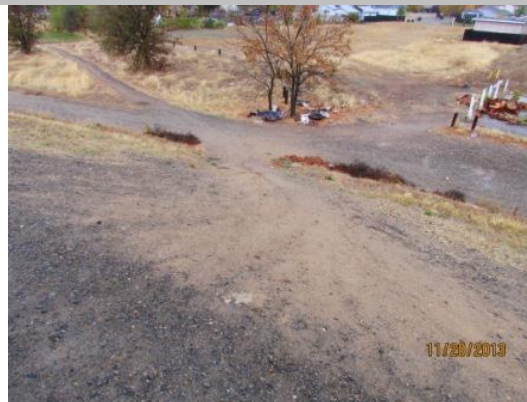
Photo 1 of 1 : mkhashch_s_20140428_00310.jpg

LM Start	0.92	Rating **	M	Issue No.	19
LM End	0.92	Issue Type +	Ma	Location *	LS
Category	Earthen Levee			GPS Latitude/Longitude	
				Start	End
Item	Slope Stability			38.625733 °	38.625733 °
				-121.453153 °	-121.453153 °
DWR ID	DWR_NA0001_07_f_2013_19				
Action/Comments					
Repair the levee slope damaged by foot traffic and prevent access where possible.

View of the foot traffic on the landside levee slope.

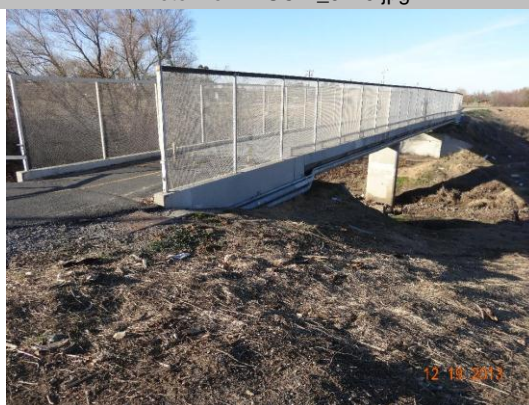
Photo 1 of 1 : UCIP_6125.jpg

LM Start	1.23	Rating **	M	Issue No.	37
LM End	1.23	Issue Type +	En	Location *	LS
Category	Supplemental			GPS Latitude/Longitude	
				Start	End
Item	DWR UCIP Field Study			38.625784 °	38.625784 °
				-121.447463 °	-121.447463 °
DWR ID	DWR_NA0001_07_s_2014_37				
Action/Comments					
Inspector Comments: FS_ID:26556					
EP_NO: 16466					
Repair Type:					
Crossing Status:					
UCIP Comments:					
FIELD_STRUCT_DESC: Two 6-inch and one 2-inch concrete encased steel utility conduits through the levee, all approximately 2.0 feet below the crown. Manhole on the levee crown. (Permit No. 16466-1995)					
FS Date: 12/20/2013

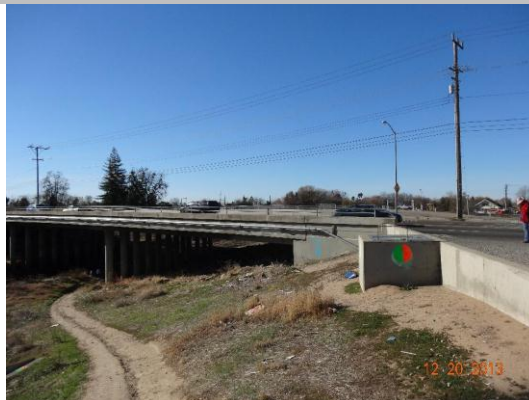
Photo 1 of 1 : UCIP_6378.jpg

LM Start	1.30	Rating **	M	Issue No.	39
LM End	1.30	Issue Type +	En	Location *	LS
Category	Supplemental			GPS Latitude/Longitude	
				Start	End
Item	DWR UCIP Field Study			38.626296 °	38.626296 °
				-121.446038 °	-121.446038 °
DWR ID	DWR_NA0001_07_s_2014_39				
Action/Comments					
Inspector Comments: FS_ID:31273					
EP_NO: 15152					
Repair Type:					
Crossing Status:					
UCIP Comments: Unable to confirm if crossing is the same one authorized through permit.					
FIELD_STRUCT_DESC: 4-inch steel gas main through the levee, 2.5 feet below the crown. Vent on the waterward shoulder. (Permit No. 15152-1989)					
FS Date: 12/20/2013

Crossing attached to upstream face of bridge.

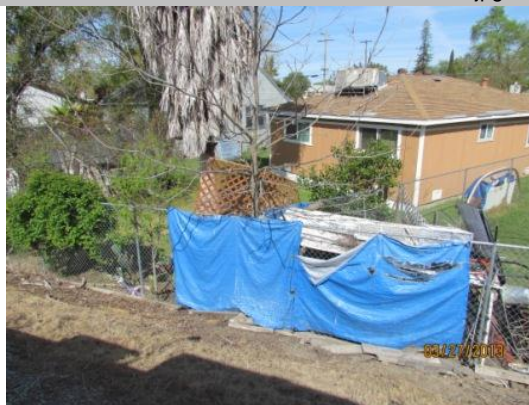
Photo 1 of 1 : mkhashch_s_20140428_00298.jpg

LM Start	1.49	Rating **	M	Issue No.	8
LM End	1.49	Issue Type +	En	Location *	LS
Category	Earthen Levee			GPS Latitude/Longitude	
				Start	End
Item	Encroachments			38.627526 °	38.627526 °
				-121.443310 °	-121.443310 °
DWR ID	DWR_NA0001_07_s_2013_8				
Action/Comments					
Fence

View of the fence obstruction visibility and access at the landside levee toe.

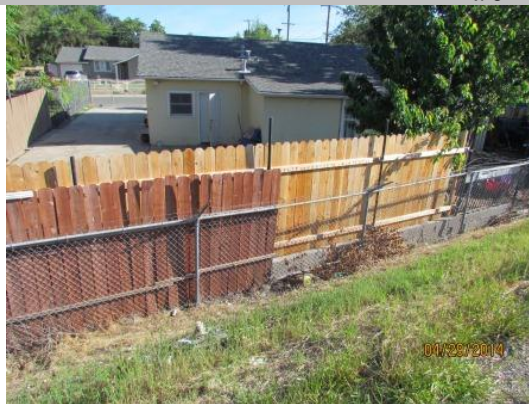
Photo 1 of 1 : mkhashch_s_20140505_00948.jpg

LM Start	1.51	Rating **	U	Issue No.	43
LM End	1.52	Issue Type +	En	Location *	LS
Category	Earthen Levee			GPS Latitude/Longitude	
				Start	End
Item	Encroachments			38.627675 °	38.627718 °
				-121.442874 °	-121.442631 °
DWR ID	DWR_NA0001_07_s_2014_43				
Action/Comments					
Fence					
Inspector Comments: New fence under construction with 18 inch CMU block base.

View of a new fence under construction at the landside levee toe.

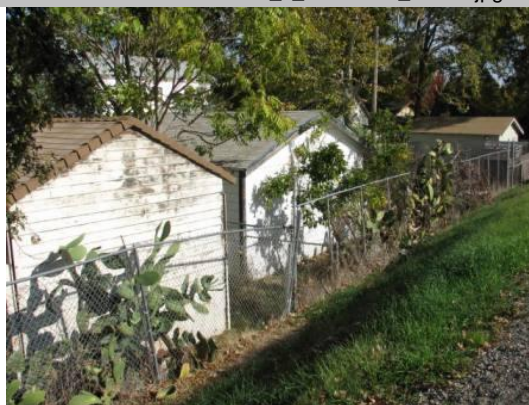
Photo 1 of 1 : mkhashch_s_20140428_00320.jpg

LM Start	1.54	Rating **	U	Issue No.	30
LM End	1.54	Issue Type +	En	Location *	LS
Category	Earthen Levee			GPS Latitude/Longitude	
				Start	End
Item	Encroachments			38.627744 °	38.627744 °
				-121.442367 °	-121.442367 °
DWR ID	DWR_NA0001_07_s_2012_30				
Action/Comments					
Building Inspector Comments: Large side building is within 10-ft of the levee toe.

11/17/2011 Building obstructs visibility and access.

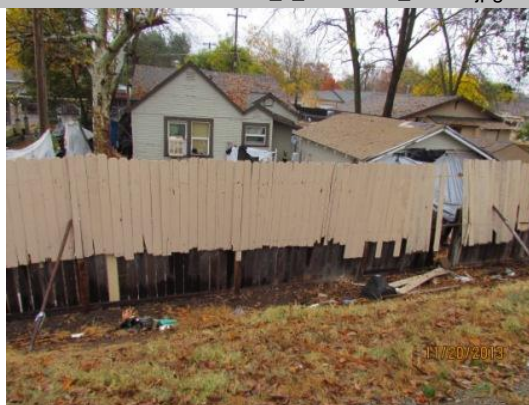
Photo 1 of 1 : mkhashch_s_20140428_00294.jpg

LM Start	1.56	Rating **	U	Issue No.	3
LM End	1.56	Issue Type +	En	Location *	LS
Category	Earthen Levee			GPS Latitude/Longitude	
				Start	End
Item	Encroachments			38.627682 °	38.627682 °
				-121.442113 °	-121.442113 °
DWR ID	DWR_NA0001_07_s_2012_3				
Action/Comments					
Fence Inspector Comments: Wooden privacy fence is within 10-ft of the levee toe.

Wooden privacy fence is constructed at the landside levee toe.

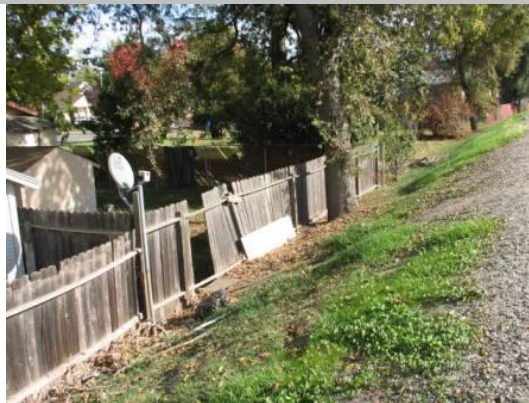
Photo 1 of 1 : mkhashch_s_20140428_00295.jpg

LM Start	1.56	Rating **	U	Issue No.	4
LM End	1.56	Issue Type +	En	Location *	LS
Category	Earthen Levee			GPS Latitude/Longitude	
				Start	End
Item	Encroachments			38.627707 °	38.627707 °
				-121.441965 °	-121.441965 °
DWR ID	DWR_NA0001_07_s _ 2012_4				
Action/Comments					
Fence Inspector Comments: Wooden privacy fence is within 10-ft of the levee toe.

11/17/2011 Wooden privacy fence is constructed at the toe.

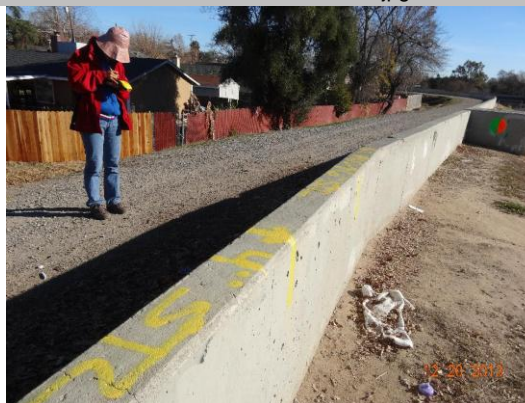
Photo 1 of 1 : UCIP_6437.jpg

LM Start	1.58	Rating **	M	Issue No.	40
LM End	1.58	Issue Type +	En	Location *	LS
Category	Supplemental			GPS Latitude/Longitude	
				Start	End
Item	DWR UCIP Field Study			38.627762 °	38.627762 °
				-121.441608 °	-121.441608 °
DWR ID	DWR_NA0001_07_s_2014_40				
Action/Comments					
Inspector Comments: FS_ID:31451					
EP_NO: N/A					
Repair Type:					
Crossing Status:					
UCIP Comments: Gas line - no markers visible. No permit available.					
FIELD_STRUCT_DESC: 1 of 2: 4-inch pipe through the levee, below					
ground elevation under the channel.					
FS Date: 12/20/2013

Underground service alert (USA) markings present on flood wall for 4-inch gas line.

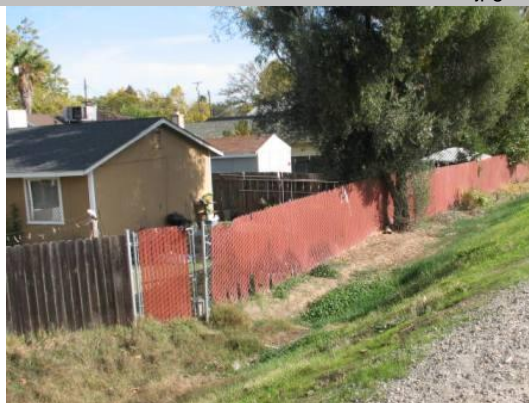
Photo 1 of 1 : mkhashch_s_20140428_00319.jpg

LM Start	1.59	Rating **	M	Issue No.	29
LM End	1.59	Issue Type +	En	Location *	LS
Category	Earthen Levee			GPS Latitude/Longitude	
				Start	End
Item	Encroachments			38.627733 °	38.627733 °
				-121.441415 °	-121.441415 °
DWR ID	DWR_NA0001_07_s _ 2012_29				
Action/Comments					
Fence					
Inspector Comments: Privacy fence is within 10-ft of the levee toe.

11/17/2011 Privacy fence is constructed at the toe.

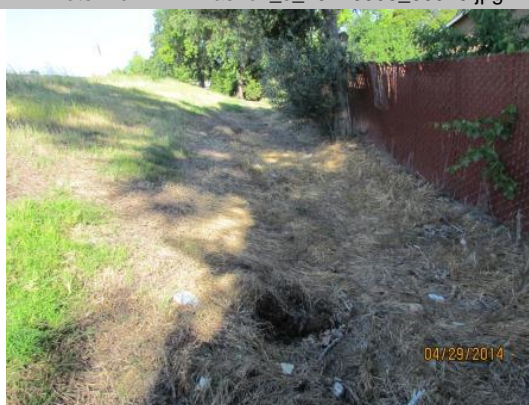
Photo 1 of 1 : mkhashch_s_20140505_00949.jpg

LM Start	1.60	Rating **	U	Issue No.	44
LM End	1.60	Issue Type +	Ma	Location *	LS
Category	Earthen Levee			GPS Latitude/Longitude	
				Start	End
Item	Trim / Thin Trees			38.627710 °	38.627710 °
				-121.441283 °	-121.441283 °
DWR ID	DWR_NA0001_07_s _ 2014_44				
Action/Comments					
Tree stumps.					
Inspector Comments: Rotted out tree stump at landside levee toe. Fill and compact the affected area.

View of the rotted out tree stump and the landside levee toe.

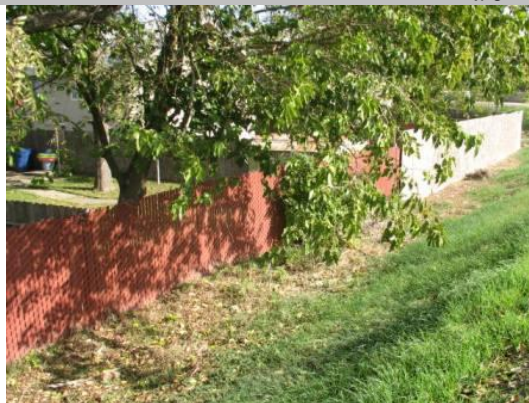
Photo 1 of 1 : mkhashch_s_20140428_00317.jpg

LM Start	1.62	Rating **	U	Issue No.	27
LM End	1.62	Issue Type +	En	Location *	LS
Category	Earthen Levee			GPS Latitude/Longitude	
				Start	End
Item	Encroachments			38.627681 °	38.627681 °
				-121.441021 °	-121.441021 °
DWR ID	DWR_NA0001_07_s _ 2012_27				
Action/Comments					
Fence					
Inspector Comments: Privacy fence and overgrown trees are within 10-ft of the levee toe.

11/17/2011 Privacy fence is constructed at the toe.

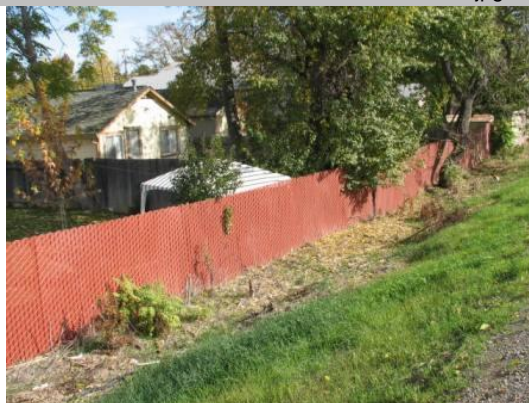
Photo 1 of 1 : mkhashch_s_20140428_00318.jpg

LM Start	1.62	Rating **	M	Issue No.	28
LM End	1.62	Issue Type +	En	Location *	LS
Category	Earthen Levee			GPS Latitude/Longitude	
				Start	End
Item	Encroachments			38.627668 °	38.627668 °
				-121.441018 °	-121.441018 °
DWR ID	DWR_NA0001_07_s _ 2012_28				
Action/Comments					
Fence					
Inspector Comments: Privacy fence is within 10-ft of the levee toe.

11/17/2011 Privacy fence is constructed at the toe.

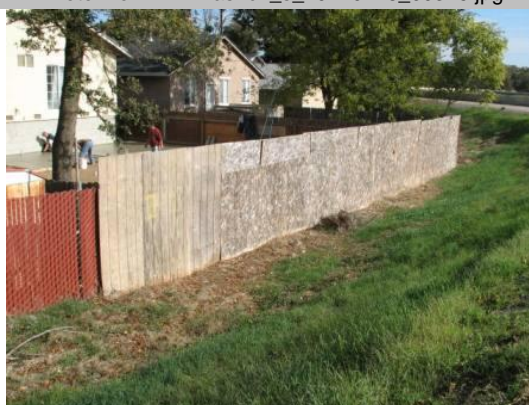
Photo 1 of 1 : mkhashch_s_20140428_00316.jpg

LM Start	1.62	Rating **	U	Issue No.	26
LM End	1.62	Issue Type +	En	Location *	LS
Category	Earthen Levee			GPS Latitude/Longitude	
				Start	End
Item	Encroachments			38.627663 °	38.627663 °
				-121.440784 °	-121.440784 °
DWR ID	DWR_NA0001_07_s _ 2012_26				
Action/Comments					
Fence					
Inspector Comments: Wooden privacy fence is within 10-ft of the levee toe.

11/17/2011 Wooden privacy fence is constructed at the toe.

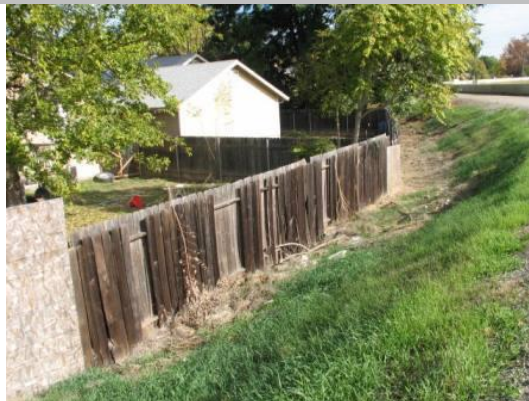
Photo 1 of 1 : mkhashch_s_20140428_00315.jpg

LM Start	1.64	Rating **	U	Issue No.	25
LM End	1.64	Issue Type +	En	Location *	LS
Category	Earthen Levee			GPS Latitude/Longitude	
				Start	End
Item	Encroachments			38.627679 °	38.627679 °
				-121.440582 °	-121.440582 °
DWR ID	DWR_NA0001_07_s _ 2012_25				
Action/Comments					
Fence Inspector Comments: Wooden privacy fence is within 10-ft of the levee toe.

11/17/2011 Wooden privacy fence is constructed at the toe.

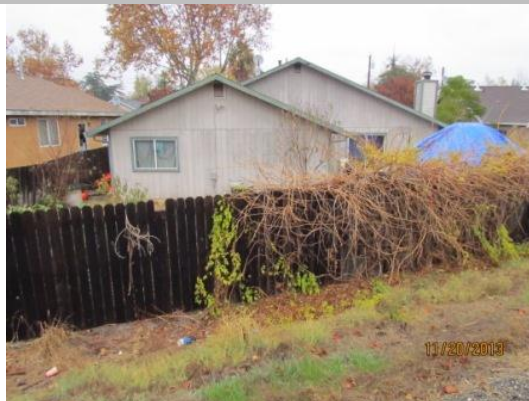
Photo 1 of 1 : mkhashch_s_20140428_00296.jpg

LM Start	1.67	Rating **	U	Issue No.	6
LM End	1.67	Issue Type +	En	Location *	LS
Category	Earthen Levee			GPS Latitude/Longitude	
				Start	End
Item	Encroachments			38.627948 °	38.627948 °
				-121.439958 °	-121.439958 °
DWR ID	DWR_NA0001_07_s _ 2012_6				
Action/Comments					
Fence Inspector Comments: Wooden privacy fence with vines are within 10-ft of the levee toe.

View of the wooden fence at the landside levee toe.

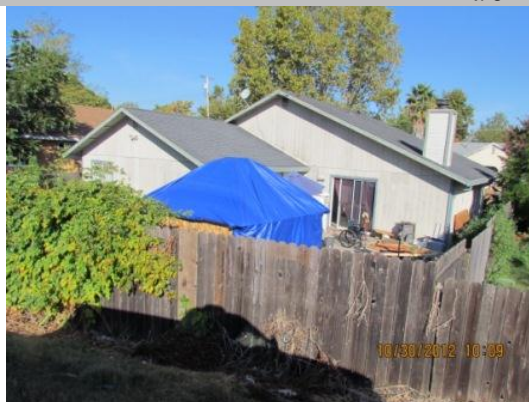
Photo 1 of 1 : mkhashch_s_20140428_00292.jpg

LM Start	1.68	Rating **	U	Issue No.	1
LM End	1.68	Issue Type +	En	Location *	LS
Category	Earthen Levee			GPS Latitude/Longitude	
				Start	End
Item	Encroachments			38.628004 °	38.628004 °
				-121.439927 °	-121.439927 °
DWR ID	DWR_NA0001_07_s _ 2012_1				
Action/Comments					
Building Inspector Comments: Construction of new structure is witin 15' of levee.

View of wood structure covered in tarp.

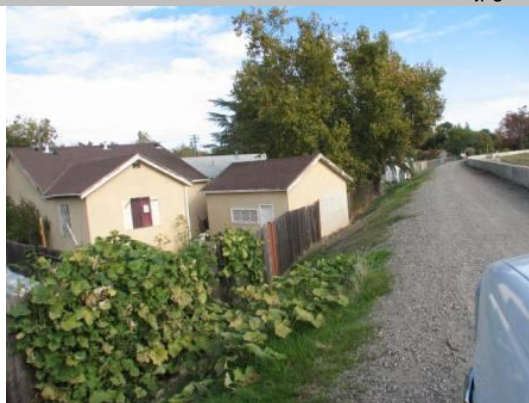
Photo 1 of 1 : mkhashch_s_20140428_00297.jpg

LM Start	1.69	Rating **	U	Issue No.	7
LM End	1.69	Issue Type +	En	Location *	LS
Category	Earthen Levee			GPS Latitude/Longitude	
				Start	End
Item	Encroachments			38.627935 °	38.627935 °
				-121.439758 °	-121.439758 °
DWR ID	DWR_NA0001_07_s _ 2012_7				
Action/Comments					
Building Inspector Comments: Corner of building protrudes into levee slope. Wooden fence is built on the levee slope.

11/17/2011 Building is constructed at the toe.

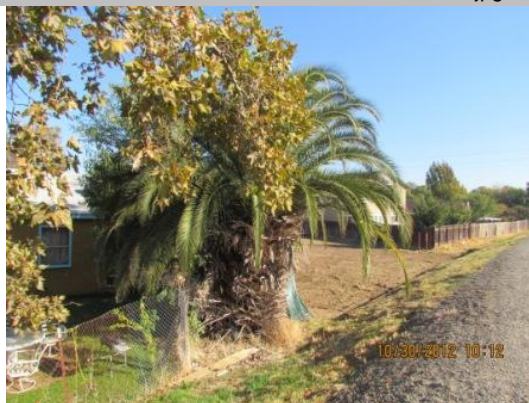
Photo 1 of 1 : mkhashch_s_20140428_00314.jpg

LM Start	1.70	Rating **	M	Issue No.	24
LM End	1.70	Issue Type +	En	Location *	LS
Category	Earthen Levee			GPS Latitude/Longitude	
				Start	End
Item	Vegetation			38.628086 °	38.628086 °
				-121.439544 °	-121.439544 °
DWR ID	DWR_NA0001_07_s _ 2012_24				
Action/Comments					
Landscaping Inspector Comments: Palm tree was trimmed up.

View of palm tree within 10-ft of the levee toe trimmed up from previous inspection.

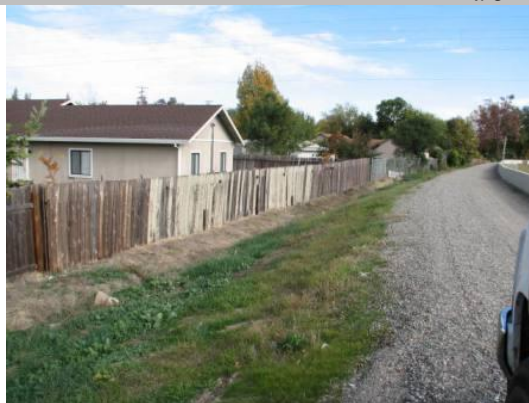
Photo 1 of 1 : mkhashch_s_20140428_00299.jpg

LM Start	1.74	Rating **	U	Issue No.	9
LM End	1.74	Issue Type +	En	Location *	LS
Category	Earthen Levee			GPS Latitude/Longitude	
				Start	End
Item	Encroachments			38.628197 °	38.628197 °
				-121.438863 °	-121.438863 °
DWR ID	DWR_NA0001_07_s_2012_9				
Action/Comments					
Fence					
Inspector Comments: Wooden privacy fence is within 10-ft of the levee toe.

11/17/2011 Wooden privacy fence is constructed at the toe.

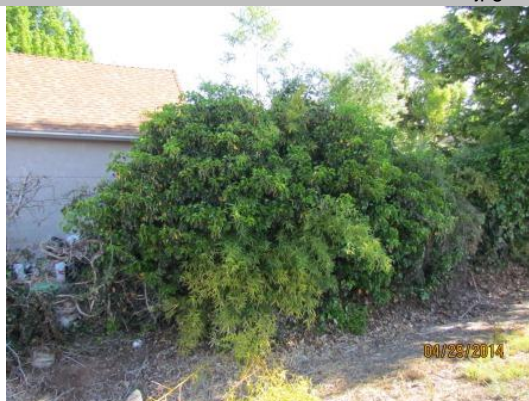
Photo 1 of 1 : mkhashch_s_20140505_00950.jpg

LM Start	1.77	Rating **	U	Issue No.	10
LM End	1.77	Issue Type +	En	Location *	LS
Category	Earthen Levee			GPS Latitude/Longitude	
				Start	End
Item	Vegetation			38.628273 °	38.628273 °
				-121.438255 °	-121.438255 °
DWR ID	DWR_NA0001_07_s_2012_10				
Action/Comments					
Landscaping Inspector Comments: Ivy and other landscape plantings have grown up chain link fence on the levee toe. Building is within 10-ft of the levee toe. Prunings are on the levee slope.

Landscaping has grown over the fence and obstructs visibility and access.

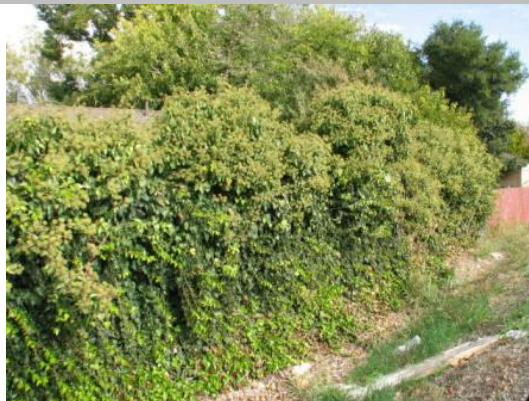
Photo 1 of 1 : mkhashch_s_20140428_00302.jpg

LM Start	1.79	Rating **	U	Issue No.	11
LM End	1.79	Issue Type +	En	Location *	LS
Category	Earthen Levee			GPS Latitude/Longitude	
				Start	End
Item	Vegetation			38.628297 °	38.628297 °
				-121.437995 °	-121.437995 °
DWR ID	DWR_NA0001_07_f_2012_11				
Action/Comments					
Landscaping					
Inspector Comments: Dense ivy and landscaping planted on chain link fence on levee toe. Porch and awning are within 10-ft of the levee toe.

11/17/2011 Overgrown vegetation obstructs visibility and access.

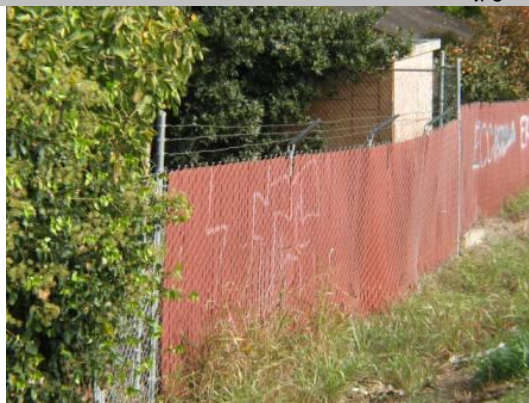
Photo 1 of 1 : mkhashch_s_20140428_00303.jpg

LM Start	1.80	Rating **	M	Issue No.	12
LM End	1.80	Issue Type +	En	Location *	LS
Category	Earthen Levee			GPS Latitude/Longitude	
				Start	End
Item	Encroachments			38.628307 °	38.628307 °
				-121.437842 °	-121.437842 °
DWR ID	DWR_NA0001_07_s_2012_12				
Action/Comments					
Fence Inspector Comments: Chain link privacy fence with barbed wire is within 10-ft of levee toe.

11/17/2011 Barbed wire topped privacy fence is located at the toe.

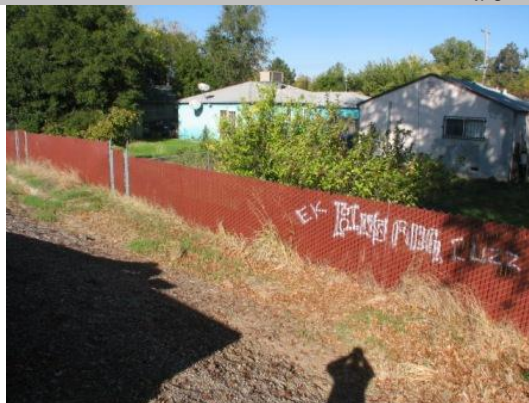
Photo 1 of 1 : mkhashch_s_20140428_00305.jpg

LM Start	1.81	Rating **	M	Issue No.	14
LM End	1.81	Issue Type +	En	Location *	LS
Category	Earthen Levee			GPS Latitude/Longitude	
				Start	End
Item	Encroachments			38.628303 °	38.628303 °
				-121.437530 °	-121.437530 °
DWR ID	DWR_NA0001_07_s _ 2012_14				
Action/Comments					
Fence					
Inspector Comments: Chain link privacy fence is within 10-ft of levee toe.

Fall 2009 photo of privacy fence within 10-ft of the levee toe obstructs visibility and access.

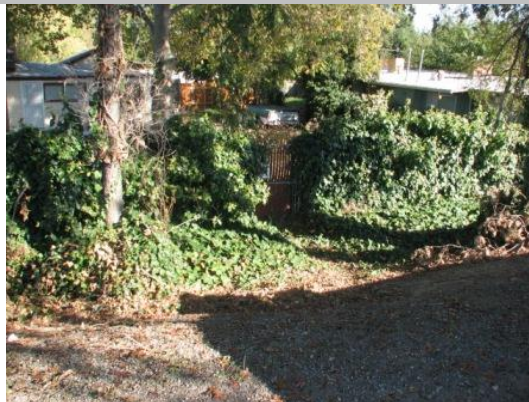
Photo 1 of 2 : mkhashch_s_20140428_00306.jpg

LM Start	1.83	Rating **	U	Issue No.	15
LM End	1.83	Issue Type +	En	Location *	LS
Category	Earthen Levee			GPS Latitude/Longitude	
				Start	End
Item	Vegetation			38.628295 °	38.628295 °
				-121.437282 °	-121.437282 °
DWR ID	DWR_NA0001_07_s _ 2012_15				
Action/Comments					
Landscaping Inspector Comments: Dense ivy growing on chain link fence within 10-ft of levee toe.

Fall 2009 photo of dense ivy and fence obstruct visibility and access.

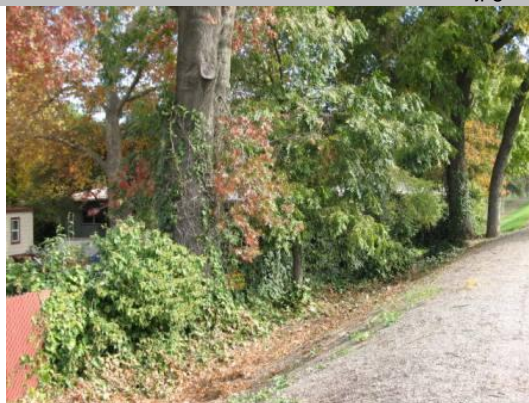
Photo 2 of 2 : mkhashch_s_20140428_00307.jpg

LM Start	1.83	Rating **	U	Issue No.	15 (cont)
LM End	1.83	Issue Type +	En	Location *	LS
Category	Earthen Levee			GPS Latitude/Longitude	
				Start	End
Item	Vegetation			38.628295 °	38.628295 °
				-121.437282 °	-121.437282 °
DWR ID	DWR_NA0001_07_s _ 2012_15				
Action/Comments					
Landscaping Inspector Comments: Dense ivy growing on chain link fence within 10-ft of levee toe.

11/17/2011 Dense vegetation at the toe.

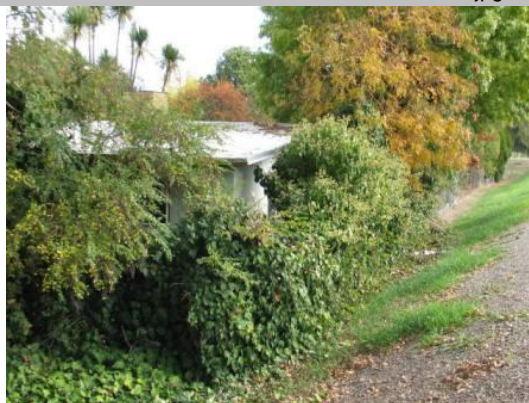
Photo 1 of 1 : mkhashch_s_20140428_00308.jpg

LM Start	1.84	Rating **	U	Issue No.	16
LM End	1.84	Issue Type +	En	Location *	LS
Category	Earthen Levee			GPS Latitude/Longitude	
				Start	End
Item	Vegetation			38.628262 °	38.628262 °
				-121.436985 °	-121.436985 °
DWR ID	DWR_NA0001_07_s _ 2012_16				
Action/Comments					
Landscaping Inspector Comments: Dense ivy and trees along chain link fence on levee toe. Large building is within 10-ft of levee toe.

11/17/2011 Vegetation and building obstruct visibility and access to the levee toe.

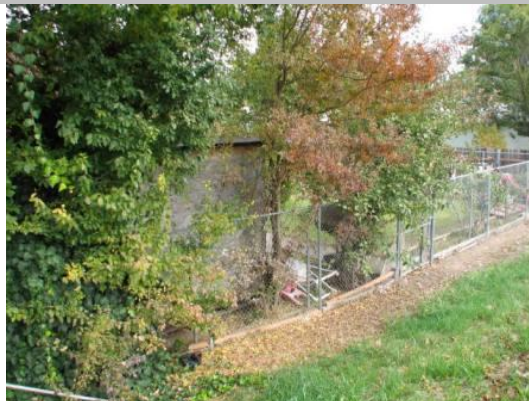
Photo 1 of 1 : mkhashch_s_20140428_00312.jpg

LM Start	1.85	Rating **	U	Issue No.	22
LM End	1.85	Issue Type +	En	Location *	LS
Category	Earthen Levee			GPS Latitude/Longitude	
				Start	End
Item	Encroachments			38.628318 °	38.628318 °
				-121.436794 °	-121.436794 °
DWR ID	DWR_NA0001_07_s _ 2012_22				
Action/Comments					
Building Inspector Comments: Wooden shed and landscaping along chain link fence within 10-ft of levee toe.

11/17/2011 Building is too close to the levee toe and obstructs visibility and access.

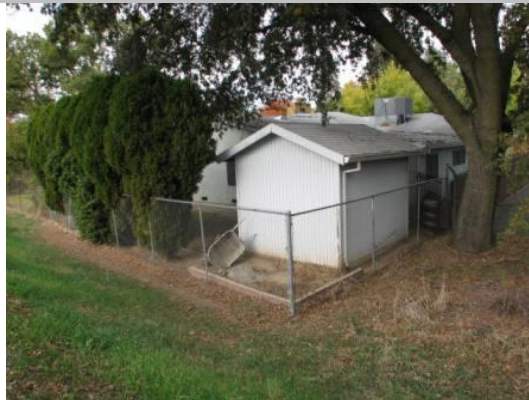
Photo 1 of 1 : mkhashch_s_20140428_00311.jpg

LM Start	1.88	Rating **	U	Issue No.	21
LM End	1.88	Issue Type +	En	Location *	LS
Category	Earthen Levee			GPS Latitude/Longitude	
				Start	End
Item	Vegetation			38.628280 °	38.628280 °
				-121.436365 °	-121.436365 °
DWR ID	DWR_NA0001_07_s _ 2012_21				
Action/Comments					
Landscaping Inspector Comments: Wooden side building and juniper trees along chain link fence are within 10-ft of landside toe.

11/17/2011 Building and landscaping are too close to the levee toe.

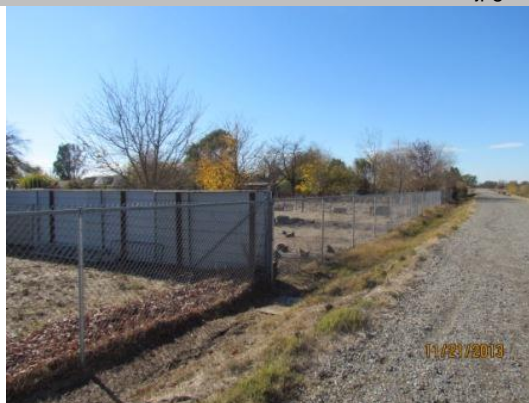
Photo 1 of 1 : mkhashch_s_20140428_00332.jpg

LM Start	0.31	Rating **	M	Issue No.	4
LM End	0.48	Issue Type +	En	Location *	LS
Category	Earthen Levee			GPS Latitude/Longitude	
				Start	End
Item	Encroachments			38.668191 °	38.668118 °
				-121.442059 °	-121.438659 °
DWR ID	DWR_NA0001_08_s _ 2012_4				
Action/Comments					
Fence					
Inspector Comments: Chain link fence near levee toe limits access.

View of the chainlink fence at landside levee toe facing downstream.

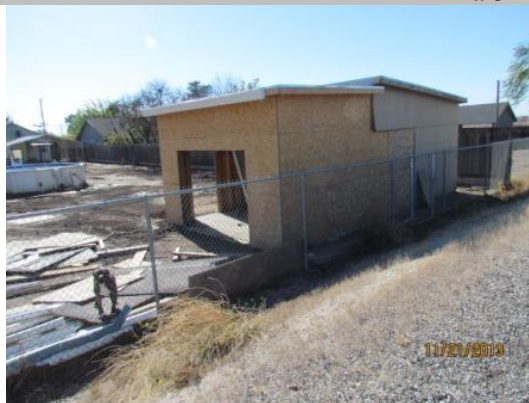
Photo 1 of 1 : mkhashch_s_20140428_00338.jpg

LM Start	0.33	Rating **	U	Issue No.	15
LM End	0.33	Issue Type +	En	Location *	LS
Category	Earthen Levee			GPS Latitude/Longitude	
				Start	End
Item	Encroachments			38.668135 °	38.668135 °
				-121.441563 °	-121.441563 °
DWR ID	DWR_NA0001_08_f _ 2013_15				
Action/Comments					
Building					
Inspector Comments: Building under construction within 10 feet of landside levee toe.

View of the building under long term construction or remodel within 10 feet of landside levee toe, facing downstream.

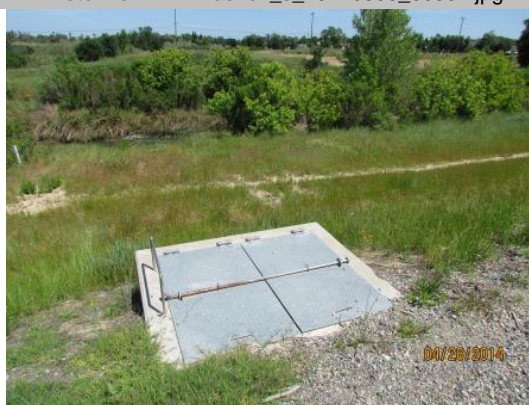
Photo 1 of 1 : mkhashch_s_20140505_00937.jpg

LM Start	0.41	Rating **	A/W	Issue No.	21
LM End	0.41	Issue Type +	En	Location *	CR
Category	Earthen Levee			GPS Latitude/Longitude	
				Start	End
Item	Encroachments			38.668159 °	38.668159 °
				-121.440008 °	-121.440008 °
DWR ID	DWR_NA0001_08_s _ 2014_21				
Action/Comments					
Pipe					
Inspector Comments: Drainage pipe crossing the levee.

View of the pipe from levee crown.

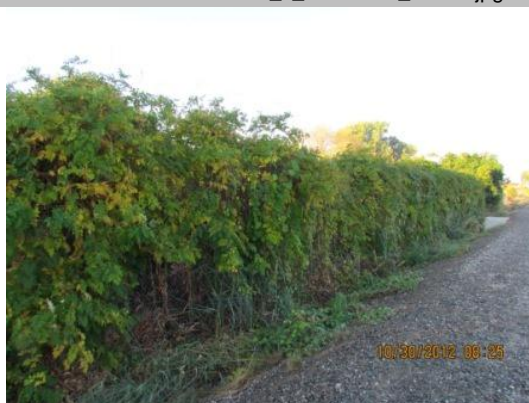
Photo 1 of 1 : mkhashch_s_20140428_00333.jpg

LM Start	0.43	Rating **	M	Issue No.	6
LM End	0.43	Issue Type +	En	Location *	LS
Category	Earthen Levee			GPS Latitude/Longitude	
				Start	End
Item	Vegetation			38.668141 °	38.668147 °
				-121.439755 °	-121.440248 °
DWR ID	DWR_NA0001_08_s _ 2012_6				
Action/Comments					
Landscaping					
Inspector Comments: Vines on fence limit visibility.

View of the vines on fence obstructing visibility of landside toe.

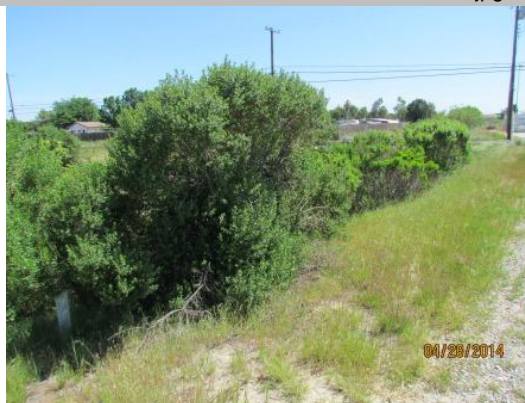
Photo 1 of 1 : mkhashch_s_20140505_00936.jpg

LM Start	0.48	Rating **	U	Issue No.	14
LM End	0.48	Issue Type +	Ma	Location *	LS
Category	Earthen Levee			GPS Latitude/Longitude	
				Start	End
Item	Vegetation			38.668110 °	38.668110 °
				-121.438727 °	-121.438727 °
DWR ID	DWR_NA0001_08_s _ 2013_14				
Action/Comments					
Remove the wild growth other than native grasses from the levee slopes. Inspector Comments: Shrubs continue to encroach up the waterside levee slope, obstructing visibility and access.

View of the woody vegetation on the waterside levee slope.

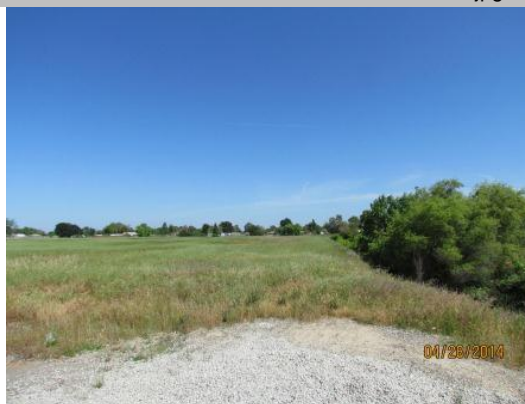
Photo 1 of 1 : mkhashch_s_20140505_00935.jpg

LM Start	0.51	Rating **	U	Issue No.	1
LM End	1.02	Issue Type +	En	Location *	WS
Category	Earthen Levee			GPS Latitude/Longitude	
				Start	End
Item	Encroachments			38.668132 °	38.665528 °
				-121.438229 °	-121.431688 °
DWR ID	DWR_NA0001_08_s _ 2012_1				
Action/Comments					
Material Inspector Comments: This portion of the levee is inaccessible for maintenance.

View from downstream end of inaccessible portion of Magpie Creek due to landowner restrictions. There is no levee for ARFCD to maintain at this location. However, the channel maintenance is the responsibility of Sacramento Yard.

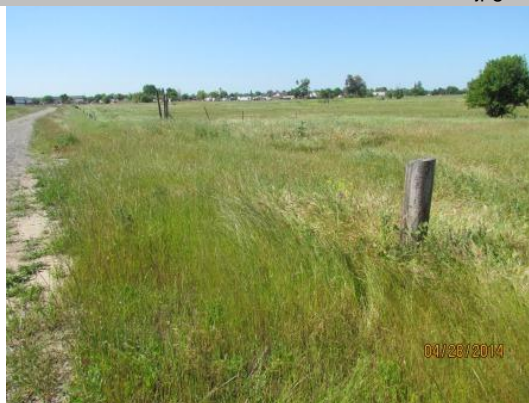
Photo 1 of 1 : mkhashch_s_20140505_00934.jpg

LM Start	1.21	Rating **	M	Issue No.	20
LM End	1.21	Issue Type +	En	Location *	LS
Category	Earthen Levee			GPS Latitude/Longitude	
				Start	End
Item	Encroachments			38.662860 °	38.662860 °
				-121.431671 °	-121.431671 °
DWR ID	DWR_NA0001_08_s_2014_20				
Action/Comments					
Pole

View of the pole on landside levee toe.

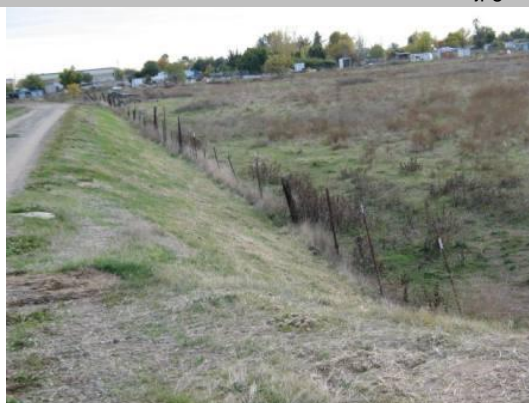
Photo 1 of 1 : mkhashch_s_20140428_00330.jpg

LM Start	1.22	Rating **	M	Issue No.	2
LM End	1.28	Issue Type +	En	Location *	LS
Category	Earthen Levee			GPS Latitude/Longitude	
				Start	End
Item	Encroachments			38.662715 °	38.661584 °
				-121.431666 °	-121.431402 °
DWR ID	DWR_NA0001_08_s_2012_2				
Action/Comments					
Fence					
Inspector Comments: Barbed wire fence runs along the levee toe.

11/17/2011 Barbed wire fence at levee toe.

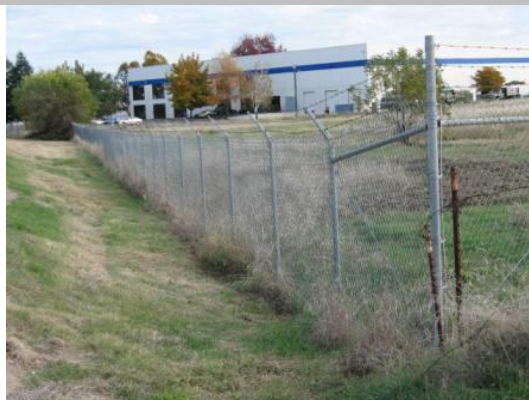
Photo 1 of 1 : mkhashch_s_20140428_00334.jpg

LM Start	1.29	Rating **	M	Issue No.	7
LM End	1.32	Issue Type +	En	Location *	LS
Category	Earthen Levee			GPS Latitude/Longitude	
				Start	End
Item	Encroachments			38.661593 °	38.661370 °
				-121.431420 °	-121.430943 °
DWR ID	DWR_NA0001_08_s_2012_7				
Action/Comments					
Fence					
Inspector Comments: Cyclone fence with barbed wire within 10' of toe for part of its alignment.

11/17/2011 Chainlink fence at levee toe.

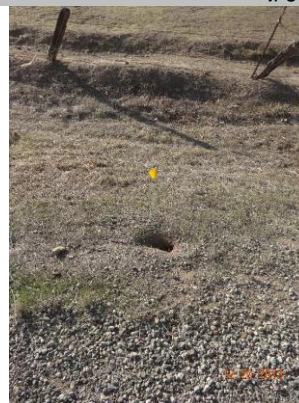
Photo 1 of 1 : UCIP_6301.jpg

LM Start	1.32	Rating **	M	Issue No.	16
LM End	1.32	Issue Type +	En	Location *	LS
Category	Supplemental			GPS Latitude/Longitude	
				Start	End
Item	DWR UCIP Field Study			38.661843 °	38.661843 °
				-121.431675 °	-121.431675 °
DWR ID	DWR_NA0001_08_s_2014_16				
Action/Comments					
Inspector Comments: FS_ID:30689					
EP_NO: N/A					
Repair Type:					
Crossing Status:					
UCIP Comments: unable to confirm if conduit or gas line cross levee or					
flag identifying problem areas. Need additional information.					
FIELD_STRUCT_DESC: Underground service alert (USA) markers					
found on waterward and landward side during field inspection.					
FS Date: 12/20/2013

View of landward side.

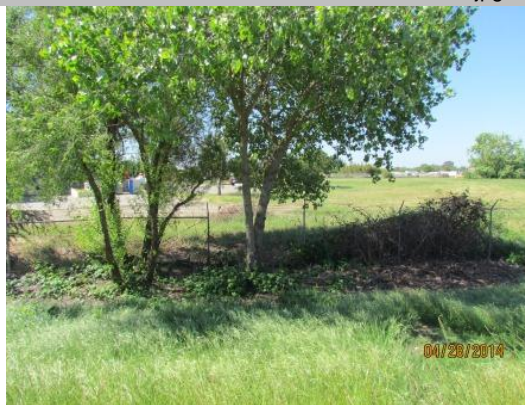
Photo 1 of 1 : mkhashch_s_20140505_00933.jpg

LM Start	1.38	Rating **	M	Issue No.	13
LM End	1.38	Issue Type +	Ma	Location *	LS
Category	Earthen Levee			GPS Latitude/Longitude	
				Start	End
Item	Vegetation			38.660987 °	38.660987 °
				-121.430120 °	-121.430120 °
DWR ID	DWR_NA0001_08_s_2013_13				
Action/Comments					
Remove the wild growth other than native grasses from the levee slopes.					
Inspector Comments: The LMA has significantly improved this location and is in the final stages of exterminating invasive vegetation.

View of the woody vegetation to be removed from the landside levee toe.

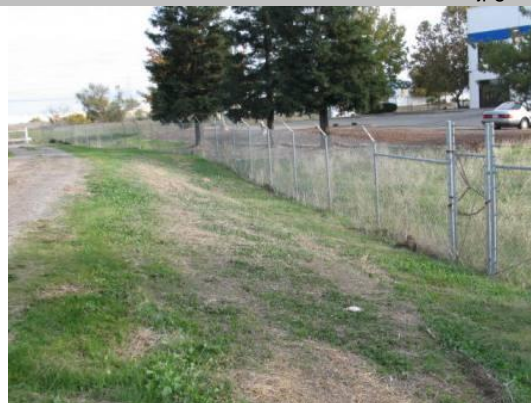
Photo 1 of 1 : mkhashch_s_20140428_00335.jpg

LM Start	1.38	Rating **	M	Issue No.	8
LM End	1.42	Issue Type +	En	Location *	LS
Category	Earthen Levee			GPS Latitude/Longitude	
				Start	End
Item	Encroachments			38.660968 °	38.660828 °
				-121.430023 °	-121.429428 °
DWR ID	DWR_NA0001_08_s _ 2013_8				
Action/Comments					
Fence Inspector Comments: Cyclone fence alignment returns to within 10' of toe.

11/17/2011 Chainlink fence alignment returns to the levee toe.

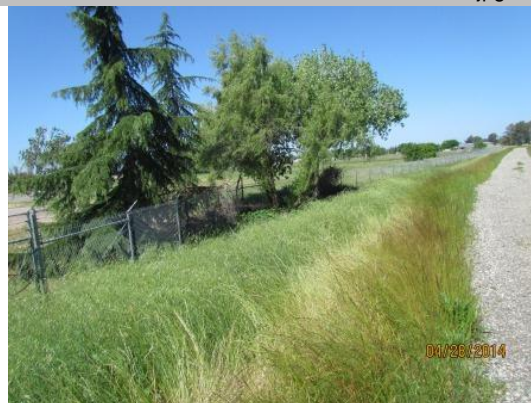
Photo 1 of 1 : mkhashch_s_20140505_00932.jpg

LM Start	1.39	Rating **	M	Issue No.	19
LM End	1.39	Issue Type +	Ma	Location *	LS
Category	Earthen Levee			GPS Latitude/Longitude	
				Start	End
Item	Vegetation			38.660928 °	38.660928 °
				-121.429930 °	-121.429930 °
DWR ID	DWR_NA0001_08_s _ 2014_19				
Action/Comments					
Control annual grass and weeds on the levee slopes and easements. Inspector Comments: Tall vegetation on landside levee slope obstructing visibility.

View of the tall vegetation on landside levee slope.

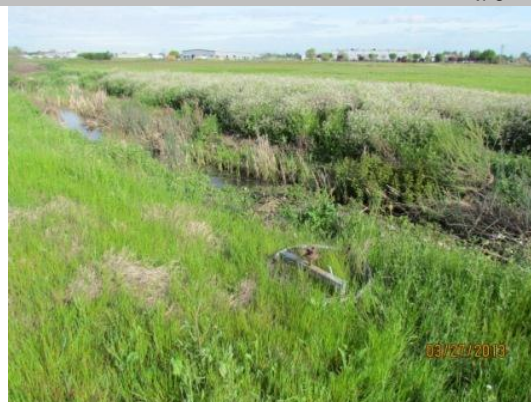
Photo 1 of 1 : mkhashch_s_20140428_00331.jpg

LM Start	1.39	Rating **	A/W	Issue No.	3
LM End	1.39	Issue Type +	En	Location *	WS
Category	Earthen Levee			GPS Latitude/Longitude	
				Start	End
Item	Encroachments			38.660896 °	38.660896 °
				-121.429888 °	-121.429888 °
DWR ID	DWR_NA0001_08_s _ 2013_3				
Action/Comments					
Pipe

View of the gate valve at the waterside levee hinge.

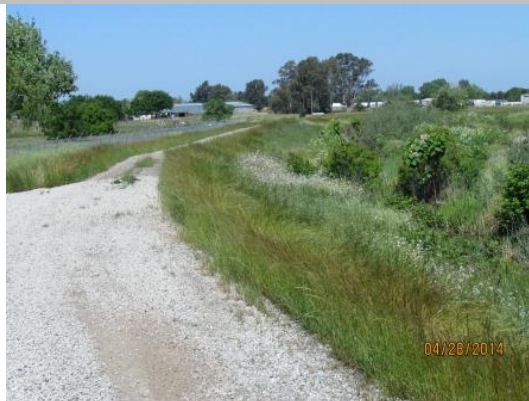
Photo 1 of 1 : mkhashch_s_20140505_00931.jpg

LM Start	1.42	Rating **	M	Issue No.	18
LM End	1.42	Issue Type +	Ma	Location *	WS
Category	Earthen Levee			GPS Latitude/Longitude	
				Start	End
Item	Vegetation			38.660813 °	38.660813 °
				-121.429499 °	-121.429499 °
DWR ID	DWR_NA0001_08_s _ 2014_18				
Action/Comments					
Control annual grass and weeds on the levee slopes and easements. Inspector Comments: Vegetation taller than 12 inches on waterside levee slope.

View of the tall annual vegetation on the waterside levee slope.

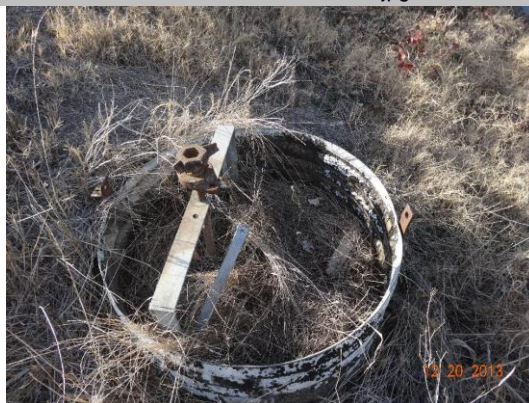
Photo 1 of 1 : UCIP_6205.jpg

LM Start	1.44	Rating **	M	Issue No.	17
LM End	1.44	Issue Type +	En	Location *	WS
Category	Supplemental			GPS Latitude/Longitude	
				Start	End
Item	DWR UCIP Field Study			38.660913 °	38.660913 °
				-121.429900 °	-121.429900 °
DWR ID	DWR_NA0001_08_s _ 2014_17				
Action/Comments					
Inspector Comments: FS_ID:29329					
EP_NO: N/A					
Repair Type:					
Crossing Status:					
UCIP Comments: Non-functional crossing--need to coordinate with owner, DWR-Inspector, and CVFPB to determine how to properly abandon crossing.					
FIELD_STRUCT_DESC: Abandoned 24-inch pipe through the levee, 8.0 feet below the crown. Two CM cutoff walls around pipe. Slide gate in 30-inch CM riser and flap gate at waterward end. Concrete "U" headwall and splash apron on waterward end. Landward end cutoff and plugged, riser filled with dirt. (USACE-1959). This entry matches the Drainage or Irrigation Structure referenced in O&M manual (Station 72+10).

Slide gate non-functional--riser filled with soil.

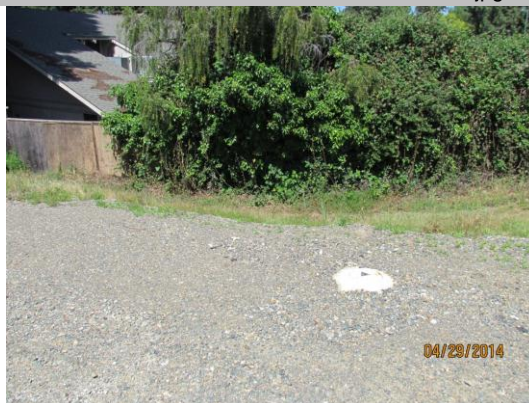
Photo 1 of 1 : mkhashch_s_20140508_00960.jpg

LM Start	0.02	Rating **	A/W	Issue No.	13
LM End	0.02	Issue Type +	En	Location *	LS
Category	Earthen Levee			GPS Latitude/Longitude	
				Start	End
Item	Encroachments			38.567955 °	38.567955 °
				-121.383623 °	-121.383623 °
DWR ID	DWR_NA0001_09_f_2013_13				
Action/Comments					
Pipe					
Inspector Comments: Monitoring well at landside levee hinge.

View of the monitoring well cap at the landside levee hinge.

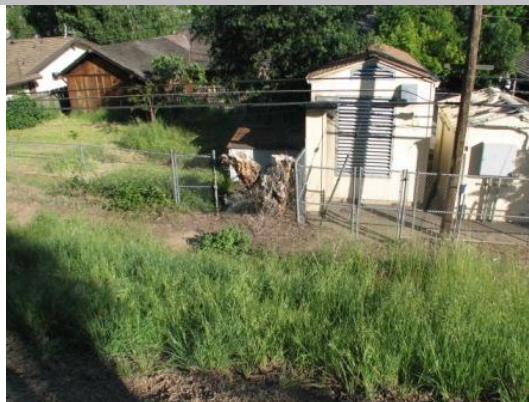
Photo 1 of 1 : mkhashch_s_20140428_00348.jpg

LM Start	0.45	Rating **	N	Issue No.	14
LM End	0.45	Issue Type +	Ma	Location *	LS
Category	Earthen Levee			GPS Latitude/Longitude	
				Start	End
Item	Trim / Thin Trees			38.566298 °	38.566298 °
				-121.390680 °	-121.390680 °
DWR ID	DWR_NA0001_09_s_2012_14				
Action/Comments					
Tree stumps.					
Inspector Comments: Tree trunk at fence line.

Tree trunk at fence line.

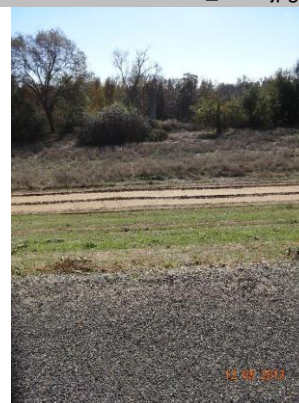
Photo 1 of 1 : UCIP_6208.jpg

LM Start	1.31	Rating **	M	Issue No.	18
LM End	1.31	Issue Type +	En	Location *	LS
Category	Supplemental			GPS Latitude/Longitude	
				Start	End
Item	DWR UCIP Field Study			38.562285 °	38.562285 °
				-121.405265 °	-121.405265 °
DWR ID	DWR_NA0001_09_s_2014_18				
Action/Comments					
Inspector Comments: FS_ID:29347					
EP_NO: N/A					
Repair Type:					
Crossing Status:					
UCIP Comments: Need to contact owner to determine status of crossing.					
FIELD_STRUCT_DESC: Abandoned 12-inch steel pipe through the levee, 14.0 feet below the crown. Riser unit on waterward side. (USACE-1959). This entry matches the Drainage or Irrigation Structure referenced in O&M manual (Station 296+85). Pipe abandonment was referenced in Permit No. 4622 (1964).					
FS Date: 12/5/2013

View of waterward side--tall riser located approximately 200 feet away.

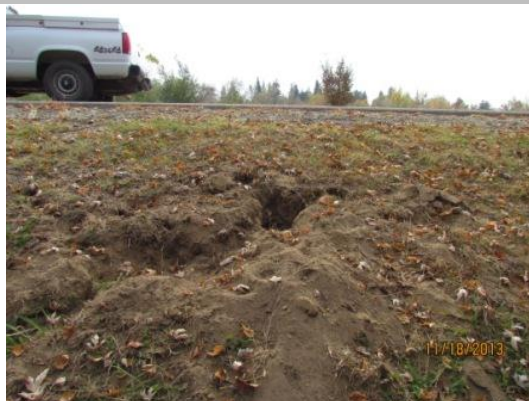
Photo 1 of 1 : mkhashch_s_20140428_00346.jpg

LM Start	1.74	Rating **	M	Issue No.	11
LM End	1.74	Issue Type +	Ma	Location *	LS
Category	Earthen Levee			GPS Latitude/Longitude	
				Start	End
Item	Animal Control			38.560812 °	38.560812 °
				-121.412803 °	-121.412803 °
DWR ID	DWR_NA0001_09_f_2013_11				
Action/Comments					
No rodents visible, but rodent burrows visible; need to backfill and compact or grout burrows.

View of the rodent hole on the landside levee slope.

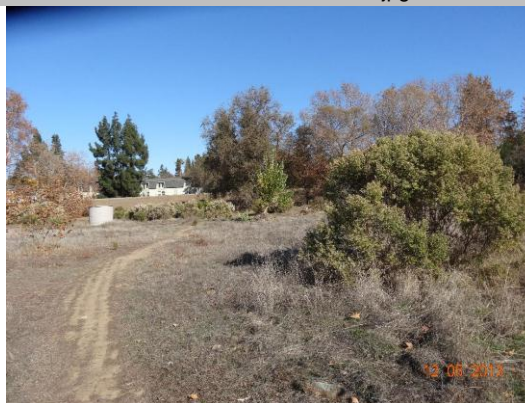
Photo 1 of 1 : UCIP_6210.jpg

LM Start	1.97	Rating **	M	Issue No.	19
LM End	1.97	Issue Type +	En	Location *	LS
Category	Supplemental			GPS Latitude/Longitude	
				Start	End
Item	DWR UCIP Field Study			38.560889 °	38.560889 °
				-121.417196 °	-121.417196 °
DWR ID	DWR_NA0001_09_s _ 2014_19				
Action/Comments					
Inspector Comments: FS_ID:29351					
EP_NO: 17587					
Repair Type:					
Crossing Status:					
UCIP Comments: Unable to confirm if riser belongs to this crossing--					
needs to coordinate with owner to determine specifics. Description					
needs to be updated.					
FIELD_STRUCT_DESC: 54-inch water main through the levee. (Permit					
No. 17587-2003)					
FS Date: 12/5/2013

View of waterward berm looking toward levee crown from waterward berm edge.

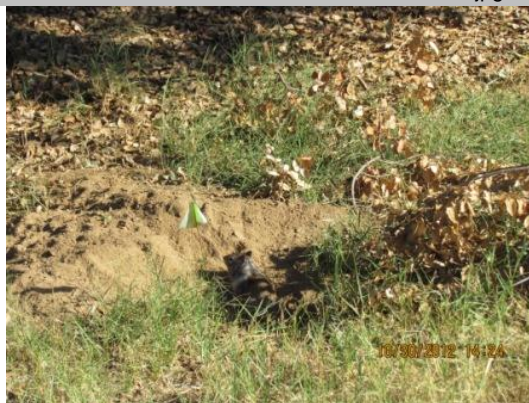
Photo 1 of 1 : mkhashch_s_20140428_00345.jpg

LM Start	3.01	Rating **	M	Issue No.	6
LM End	3.01	Issue Type +	Ma	Location *	LS
Category	Earthen Levee			GPS Latitude/Longitude	
				Start	End
Item	Animal Control			38.575035 °	38.575035 °
				-121.419802 °	-121.419802 °
DWR ID	DWR_NA0001_09_f_2012_6				
Action/Comments					
Exterminate rodents and backfill and compact or grout burrows.

View of active rodent burrow at landside levee toe.

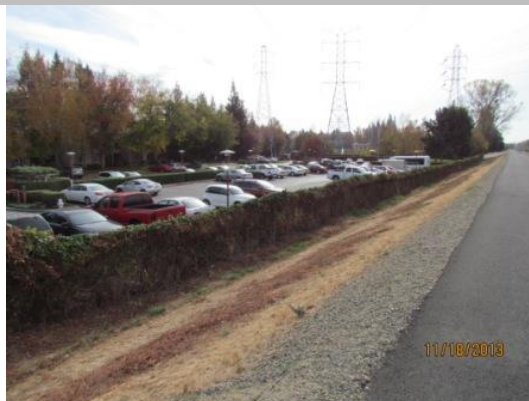
Photo 1 of 1 : mkhashch_s_20140428_00342.jpg

LM Start	3.11	Rating **	U	Issue No.	2
LM End	3.24	Issue Type +	En	Location *	LS
Category	Earthen Levee			GPS Latitude/Longitude	
				Start	End
Item	Encroachments			38.576423 °	38.578248 °
				-121.419117 °	-121.418475 °
DWR ID	DWR_NA0001_09_s_2012_2				
Action/Comments					
Fence

View of the trimmed vegetation on the chain linked fence still obstructing visibility.

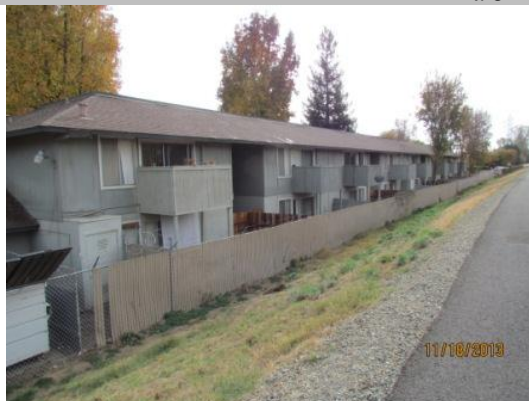
Photo 1 of 1 : mkhashch_s_20140428_00341.jpg

LM Start	3.24	Rating **	M	Issue No.	1
LM End	3.32	Issue Type +	En	Location *	LS
Category	Earthen Levee			GPS Latitude/Longitude	
				Start	End
Item	Encroachments			38.578258 °	38.579363 °
				-121.418475 °	-121.418100 °
DWR ID	DWR_NA0001_09_s_2012_1				
Action/Comments					
Fence

View of the fence at the landside levee toe.

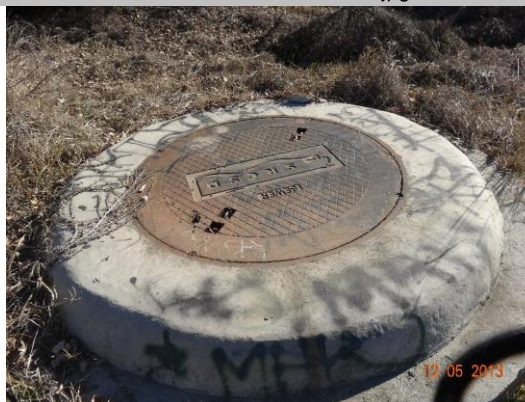
Photo 1 of 1 : UCIP_6285.jpg

LM Start	3.38	Rating **	M	Issue No.	23
LM End	3.38	Issue Type +	En	Location *	CR
Category	Supplemental			GPS Latitude/Longitude	
				Start	End
Item	DWR UCIP Field Study			38.580094 °	38.580094 °
				-121.417821 °	-121.417821 °
DWR ID	DWR_NA0001_09_s _ 2014_23				
Action/Comments					
Inspector Comments: FS_ID:30125					
EP_NO: 17671					
Repair Type:					
Crossing Status:					
UCIP Comments: unable to confirm if manhole is part of this crossing--					
need to contact owner to determine status of crossing.					
FIELD_STRUCT_DESC: 1 of 2: 60-inch sewer main under the levee.					
Connects to 60-inch main on landward side. (Permit No. 17671-2003)					
FS Date: 12/5/2013

Manhole visible on waterward toe.

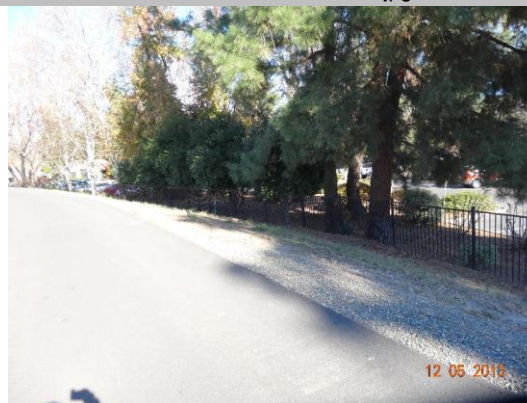
Photo 1 of 1 : UCIP_6218.jpg

LM Start	3.40	Rating **	M	Issue No.	24
LM End	3.40	Issue Type +	En	Location *	CR
Category	Supplemental			GPS Latitude/Longitude	
				Start	End
Item	DWR UCIP Field Study			38.580347 °	38.580347 °
				-121.417734 °	-121.417734 °
DWR ID	DWR_NA0001_09_s_2014_24				
Action/Comments					
Inspector Comments: FS_ID:29633					
EP_NO: 12188					
Repair Type:					
Crossing Status:					
UCIP Comments: unable to confirm if crossing is still active--need to contact owner to determine status of crossing.					
FIELD_STRUCT_DESC: 60-inch concrete encased steel sewer line through the levee, 17.0 feet below the crown. Cutoff wall around pipe at the center of the levee. Rock revetment on waterward slope. Three pressure manholes in overflow area along pipe path. (Permit No. 12188-1979)					
FS Date: 12/5/2013

View of landward side.

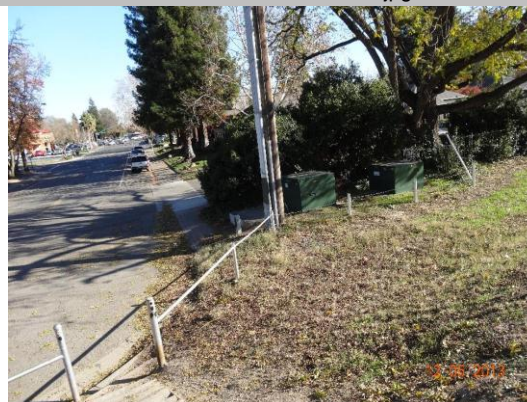
Photo 1 of 1 : UCIP_6298.jpg

LM Start	3.48	Rating **	M	Issue No.	25
LM End	3.48	Issue Type +	En	Location *	CR
Category	Supplemental			GPS Latitude/Longitude	
				Start	End
Item	DWR UCIP Field Study			38.581572 °	38.581572 °
				-121.417819 °	-121.417819 °
DWR ID	DWR_NA0001_09_s_2014_25				
Action/Comments					
Inspector Comments: FS_ID:30684					
EP_NO: N/A					
Repair Type:					
Crossing Status:					
UCIP Comments: unable to determine if crossing goes through levee.					
Need to obtain additional information to confirm crossing.					
FIELD_STRUCT_DESC: Water fountain found on waterward side.					
FS Date: 12/5/2013

View of landward side.

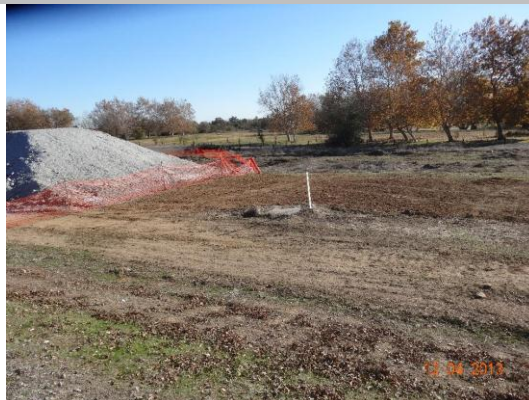
Photo 1 of 1 : UCIP_6381.jpg

LM Start	1.12	Rating **	M	Issue No.	10
LM End	1.12	Issue Type +	En	Location *	CR
Category	Supplemental			GPS Latitude/Longitude	
				Start	End
Item	DWR UCIP Field Study			38.586813 °	38.586813 °
				-121.337643 °	-121.337643 °
DWR ID	DWR_NA0001_10_s_2014_10				
Action/Comments					
Inspector Comments: FS_ID:31284					
EP_NO: N/A					
Repair Type:					
Crossing Status:					
UCIP Comments: Unable to determine reason for box and whether there is a utility that crosses levee. No permit found.					
FIELD_STRUCT_DESC: Service box located on waterward side. No permit found.					
FS Date: 12/4/2013

Concrete vault located on waterward side.

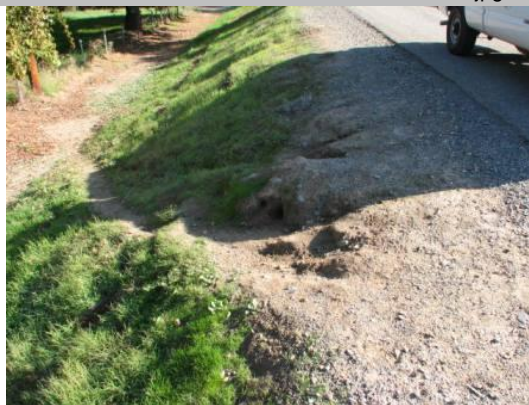
Photo 1 of 2 : mkhashch_s_20140428_00361.jpg

LM Start	3.37	Rating **	M	Issue No.	114
LM End	3.37	Issue Type +	Ma	Location *	LS
Category	Earthen Levee			GPS Latitude/Longitude	
				Start	End
Item	Erosion / Bank Caving			38.569866 °	38.569866 °
				-121.371403 °	-121.371403 °
DWR ID	DWR_NA0001_10_s_2012_114				
Action/Comments					
Note and monitor erosion site.					
Inspector Comments: Erosion occurring at junction of footpath and burrow at the hinge point.

11/16/2011 Erosion from pedestrian traffic, burrow can be seen in the photo in the lower portion of the shadow.

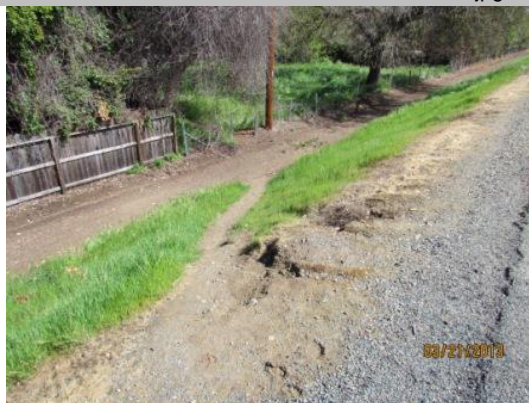
Photo 2 of 2 : mkhashch_s_20140428_00362.jpg

LM Start	3.37	Rating **	M	Issue No.	114 (cont)	
LM End	3.37	Issue Type +	Ma	Location *	LS	
Category	Earthen Levee			GPS Latitude/Longitude		
				Start	End	
Item	Erosion / Bank Caving			38.569866 °	38.569866 °	
				-121.371403 °	-121.371403 °	
DWR ID	DWR_NA0001_10_s_2012_114					
Action/Comments						
Note and monitor erosion site.						
Inspector Comments: Erosion occurring at junction of footpath and burrow at the hinge point.

View of the erosion on the landside levee slope from pedestrian traffic.
